Investigation of the December 6, 2007 Fatal Parking Garage Collapse at Berkman Plaza 2, Jacksonville, FL

Report Prepared by
Mohammad Ayub, PE

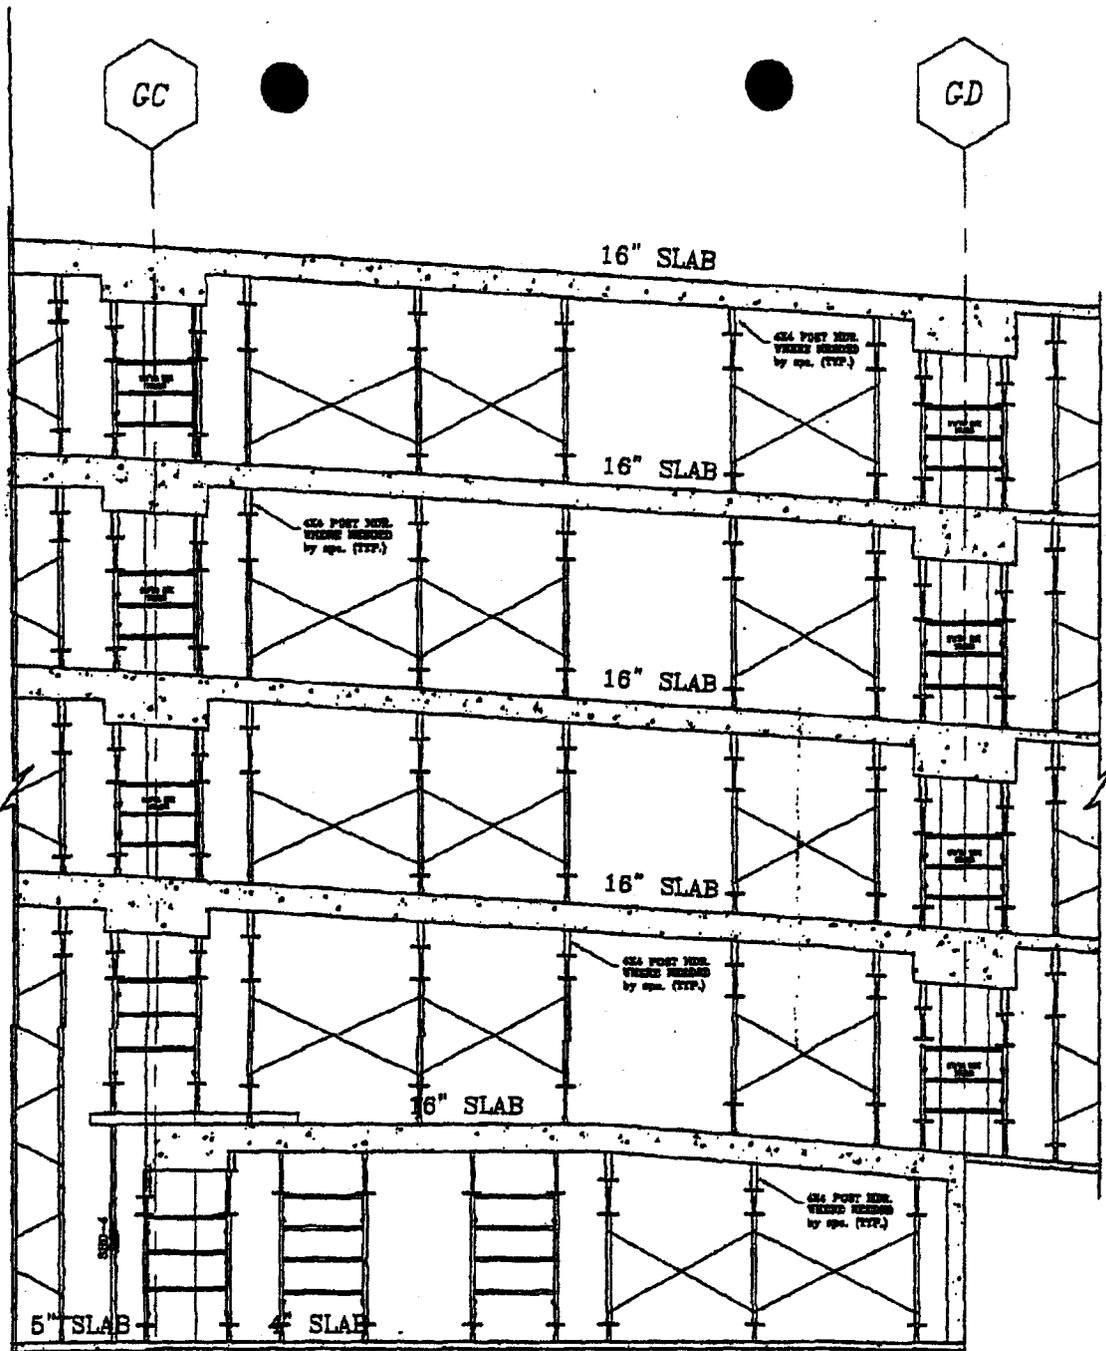
FIGURE 3

number 8607K038, re-shores were indicated extending down to the 1st level. It required that at the time the 6th level was cast, all levels below the 6th level must be shored/reshored. See, Fig. 3.

6. The shoring subcontractor disregarded the shoring plans prepared by its subcontractor which indicated that the 3rd level should be reshored down to the 1st level. There were no
