United States of America
OCCUPATIONAL SAFETY AND HEALTH REVIEW COMMISSION
1120 20th Street, N.W., Ninth Floor
Washington, DC 20036-3457

CHEWY, INC.,

OSHRC DOCKET NO. 19-0868

DECISION AND ORDER

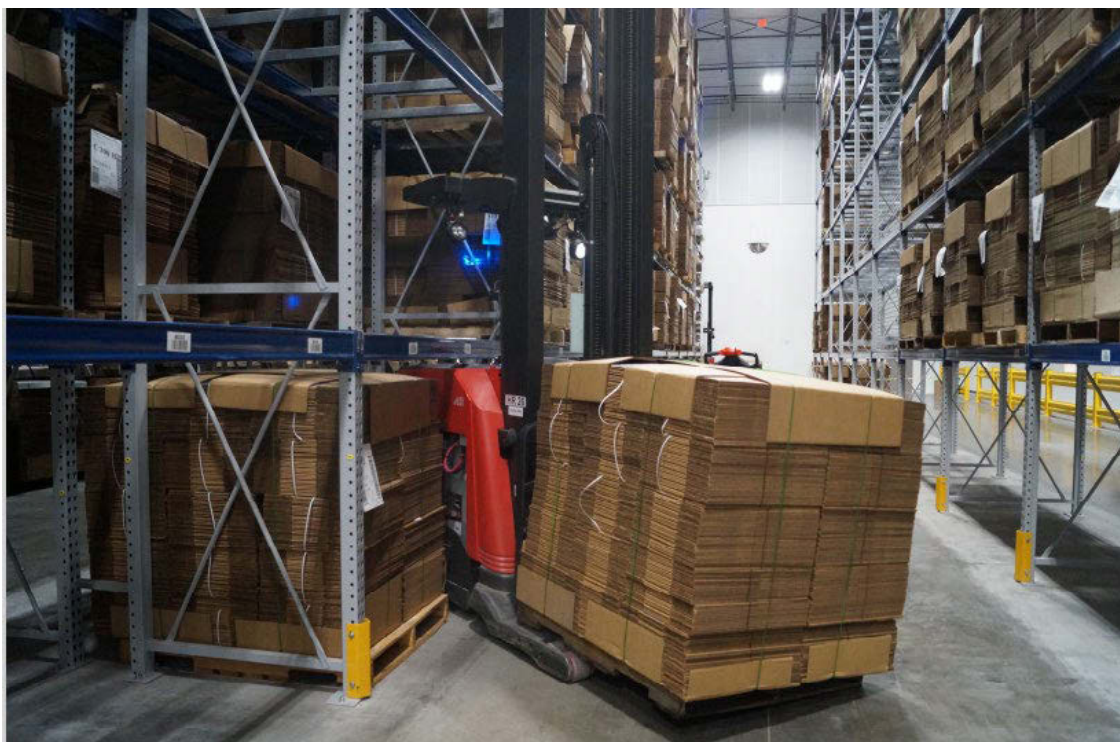
(Ex. CX-12.)

For this Citation Item, the Secretary alleges that the conditions at Chewy’s Ocala warehouse presented an “under-ride” hazard to Chewy’s workers and proposes a \$13,260 penalty. (First Am. Compl. 3.)² Below is a picture that truly and accurately depicts the condition inside Chewy’s Ocala warehouse shortly after the incident that initiated the OSHA inspection in this case. The photo shows the lift truck frame, where the operator had been standing, under the rack system horizontal beam, and a pallet of boxes on the lift forks. (Tr. 51-52; Ex. C-12.)
