Investigation of the December 6, 2007 Fatal Parking Garage Collapse at Berkman Plaza 2, Jacksonville, FL

Report Prepared by
Mohammad Ayub, PE

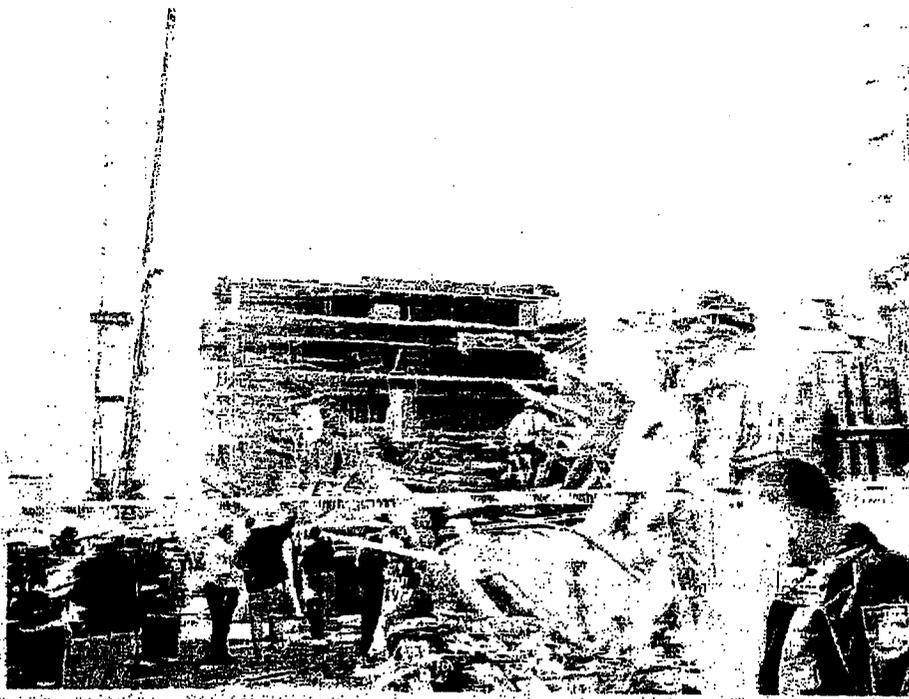
FIGURE 5

The collapse was massive as it encompassed all the elevated slabs from columns grid lines A to G and column grid lines 2 to 4. The slabs fell generally on the top of each other with the columns crushed in between. The shores and re-shores were also crushed between the collapsing slabs and beams. See Figs 5 thru 18 for the extent of the collapse. Two bays on the south side, however, remained standing with slabs north of column grid line G hanging towards the north, still connected by rebars and post-tensioning cables, see Fig. 17. The failure included the shear wall on column grid line A and the shear walls enclosing stair G1 near column grid line 2.
