United States of America
OCCUPATIONAL SAFETY AND HEALTH REVIEW COMMISSION
1120 20th Street, N.W., Ninth Floor
Washington, DC 20036-3457

U.S. POSTAL SERVICE, d/b/a Lehigh
Valley Processing & Distribution Center,

OSHRC DOCKET No. 17-0419

DECISION AND ORDER

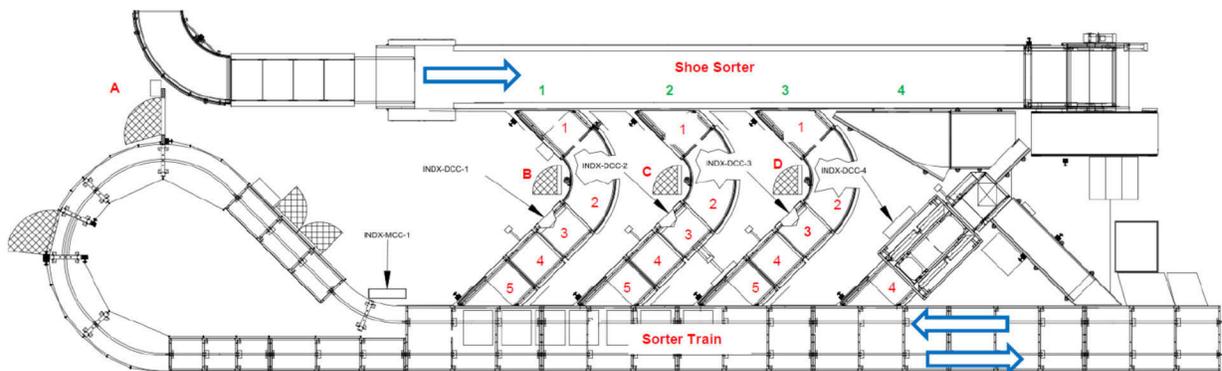
² The diagram below (Ex. R-30 at 8) reflects a bird’s-eye view of the induction area and its spatial relation to the shoe sorter (which is part of the FSD Subsystem) and the sorter train (which is part of the Sorter Subsystem). The large arrows superimposed on the shoe sorter and the sorter train indicate the direction that mail items flow.

conveyor known as the “shoe sorter” (a conveyor in the FSD Subsystem) transfers mail items onto the induction lanes, which in turn transfer the items to the “sorter train” (a conveyor in the Sorter Subsystem).

b. The three automated induction lanes are arranged adjacent and parallel to one another. (Ex. R-30 at 8). Each automated induction lane consists of five conveyor belts, numbered 1 through 5 in the order of mail flow. The top surface of the conveyor belts is elevated about 66 inches (5.5 feet) above floor level. (T. 48, 551).

15. In the repair and rebuild of belt I-3-2, the MPEs did their work while positioned on the floor area that is between induction lanes 2 and 3 as depicted in the diagram in footnote 2. In that space, the distance between the inner radius of curved belt I-3-2 and the outer radius of curved belt I-2-2 is about three feet. (T. 478). The distance from belt I-3-2 to the shoe sorter is about 3.5 feet, and the distance from belt I-3-2 to the sorter train is about 4.5 feet. (T. 551).
